Oak Creek Surface Water Quality Report for 2020
Oak Creek Watershed Council
Year of the Novel Coronavirus & the Heightened Impact on Recreation

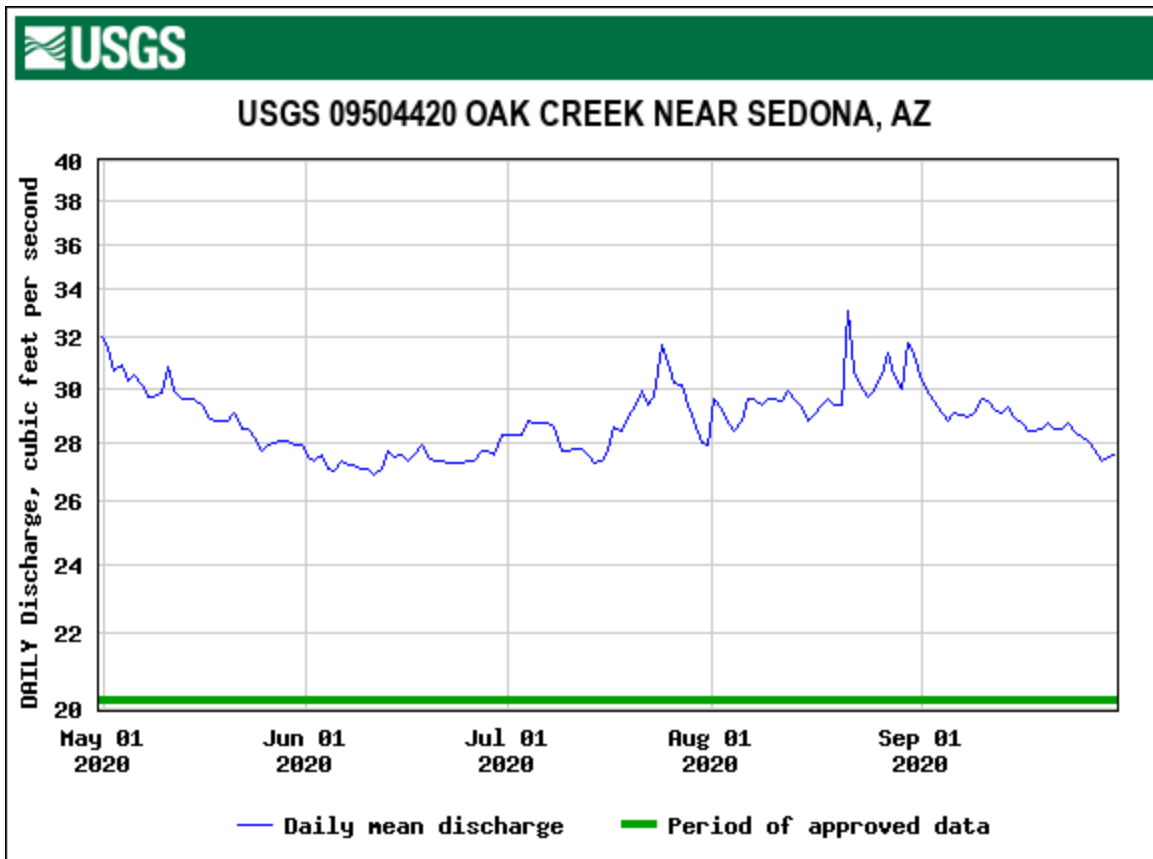
Figure 2. USGS discharge data on Oak Creek near Sedona from May–September. Shows a relatively consistent flow throughout the entire sampling season.

It is important to note that there were no flood events on Oak Creek during the study period (May–September). The USGS streamgage (Figure 2) shows a relatively consistent flow of 30 cfs throughout the entire sampling period, indicating that samples were collected during baseflow. Therefore, the exceedances captured in this season cannot be attributed to storm events and are much more likely attributable to high-impact recreation. Figure 3 shows the flood activity and associated discharge that occurred on Oak Creek during all of 2020.

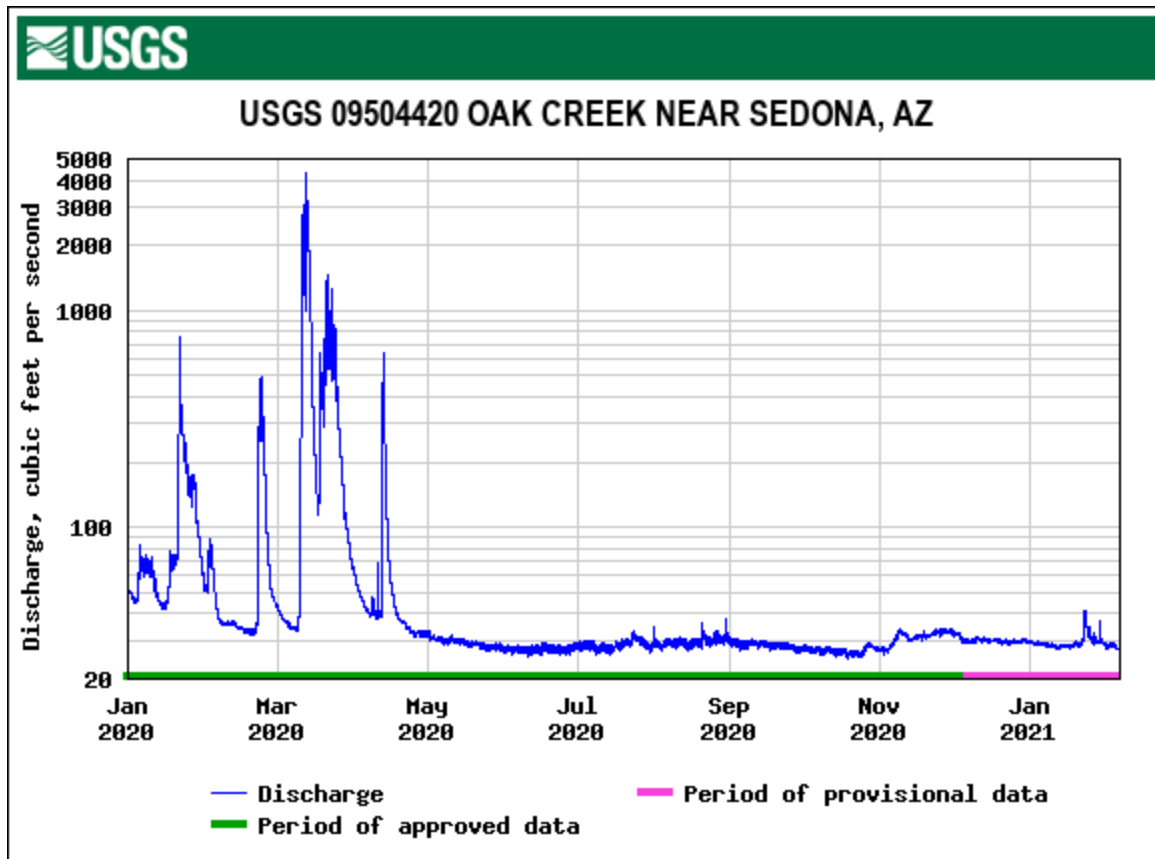
Figure 3. USGS discharge data on Oak Creek near Sedona from January 2020 – January 2021. Shows peak storm flow during the first four months of the year and a relatively consistent flow throughout the following months.

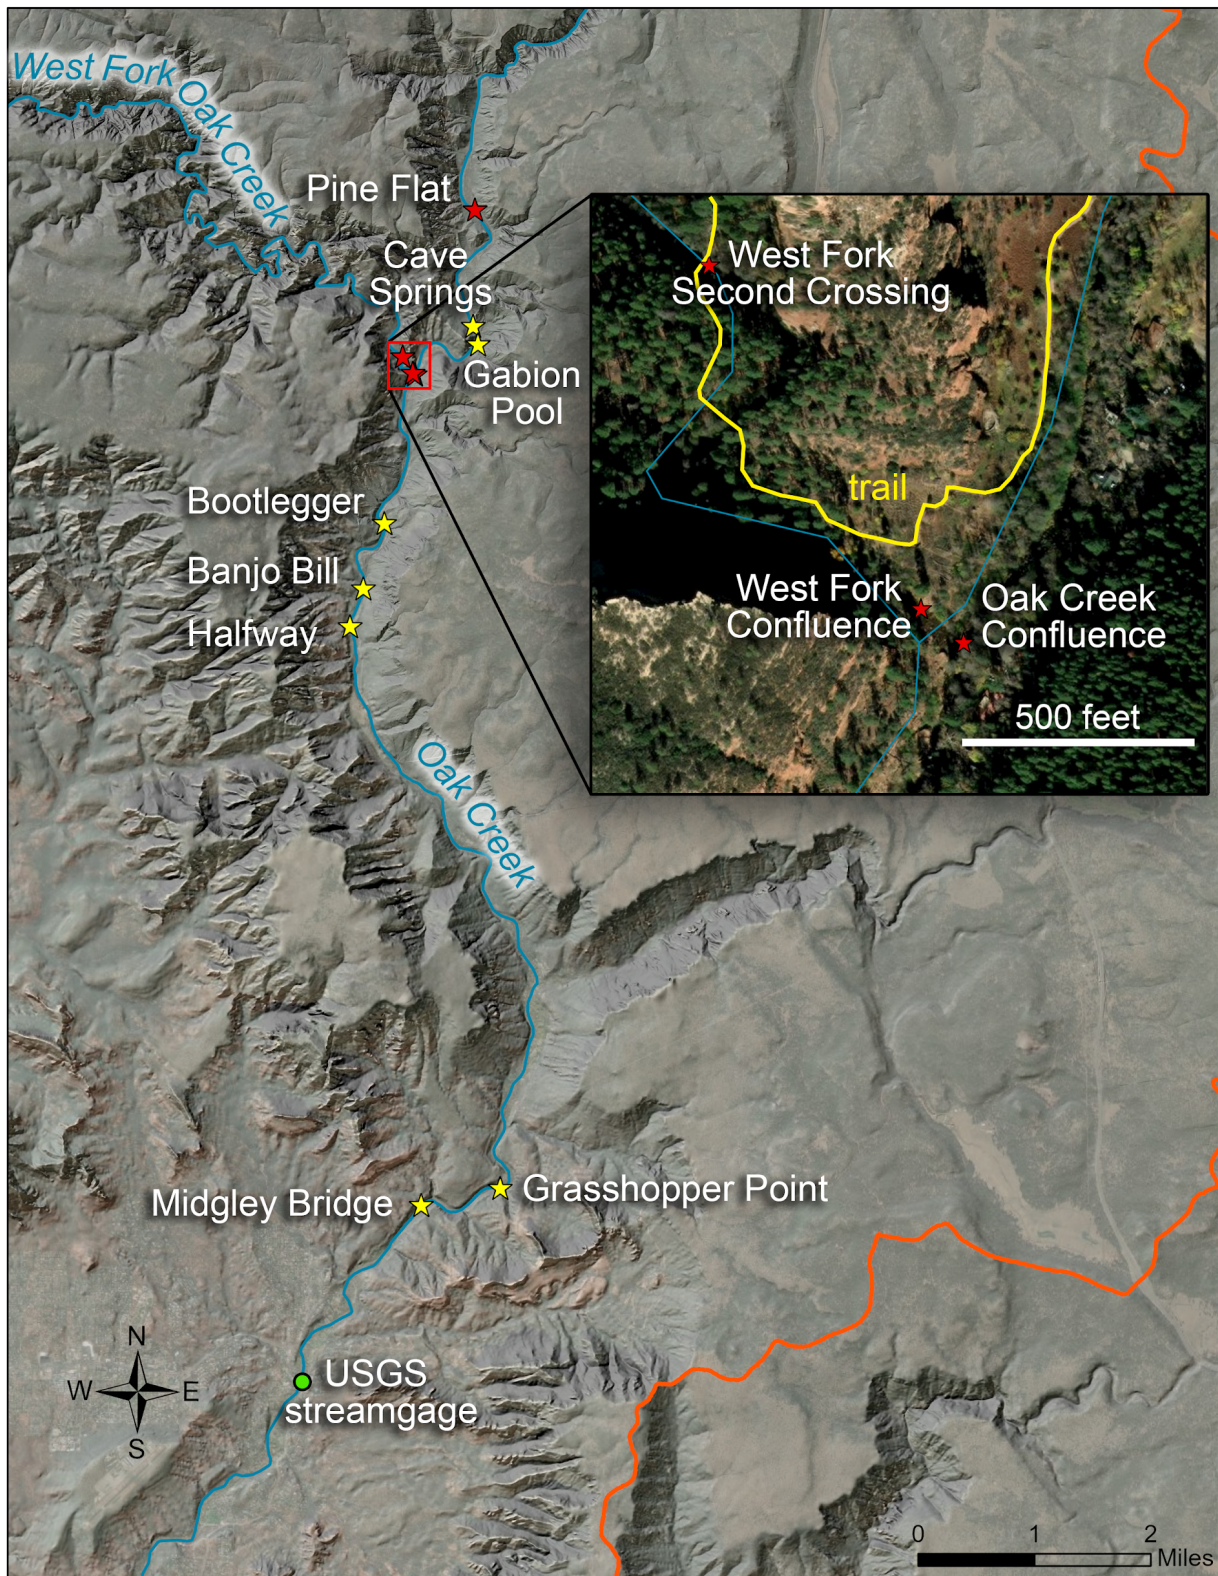
Figure 4. Map of OCWC surface water quality sampling sites. Yellow stars indicate the weekend sampling sites and red stars indicate the Tuesday sampling sites.

Pool, Bootlegger, Banjo Bill, Halfway, Grasshopper Point, and Midgley Bridge (Figure 4). Samples were collected in 100 mL IDEXX bottles along with a turbidity sample collected at each site, and a duplicate sample collected each sampling day for quality assurance purposes. Samples were placed on ice and brought to Natural Channel Designs Laboratory in Flagstaff where Ambassadors processed and analyzed *E. coli* bacteria concentrations using the IDEXX QuantiTray method and found turbidity by using a HACH turbidimeter in the field.

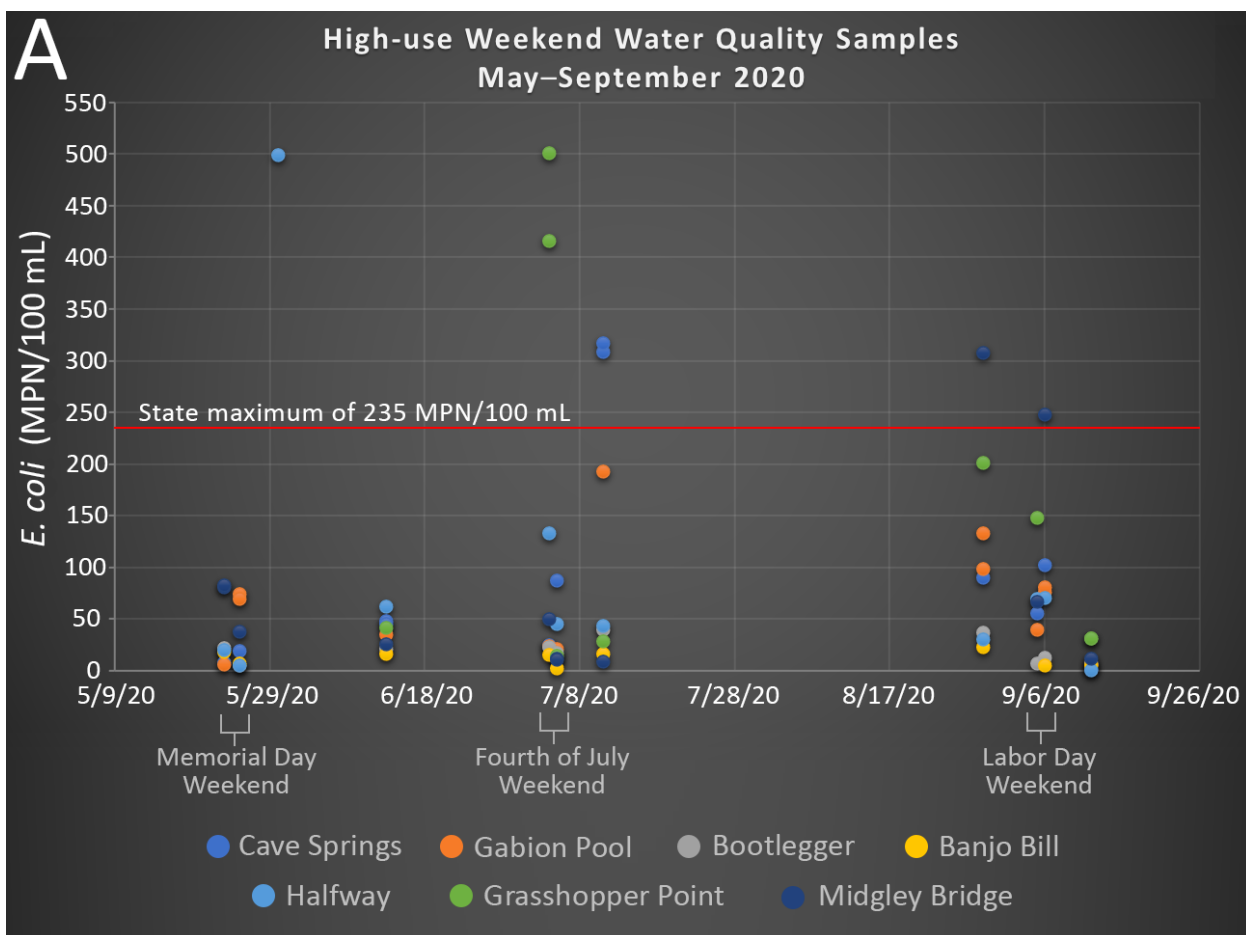
Results show that in the peak recreational time period of May through September 2020, *E. coli* numbers stayed below the recreational water quality maximum of 235 MPN/100 mL 89% of the time (Figure 5 A and B). Exceedances were seen in May, July, August, and September at Halfway, Grasshopper Point, Cave Springs, Midgley Bridge, and Banjo Bill.

Figure 5A. OCWC Weekend samples with holiday weekends labeled. Exceedances are clearly marked as above the red line indicating the state maximum of 235 MPN/100 mL. Extreme exceedances are shown in Figure 5B. below.

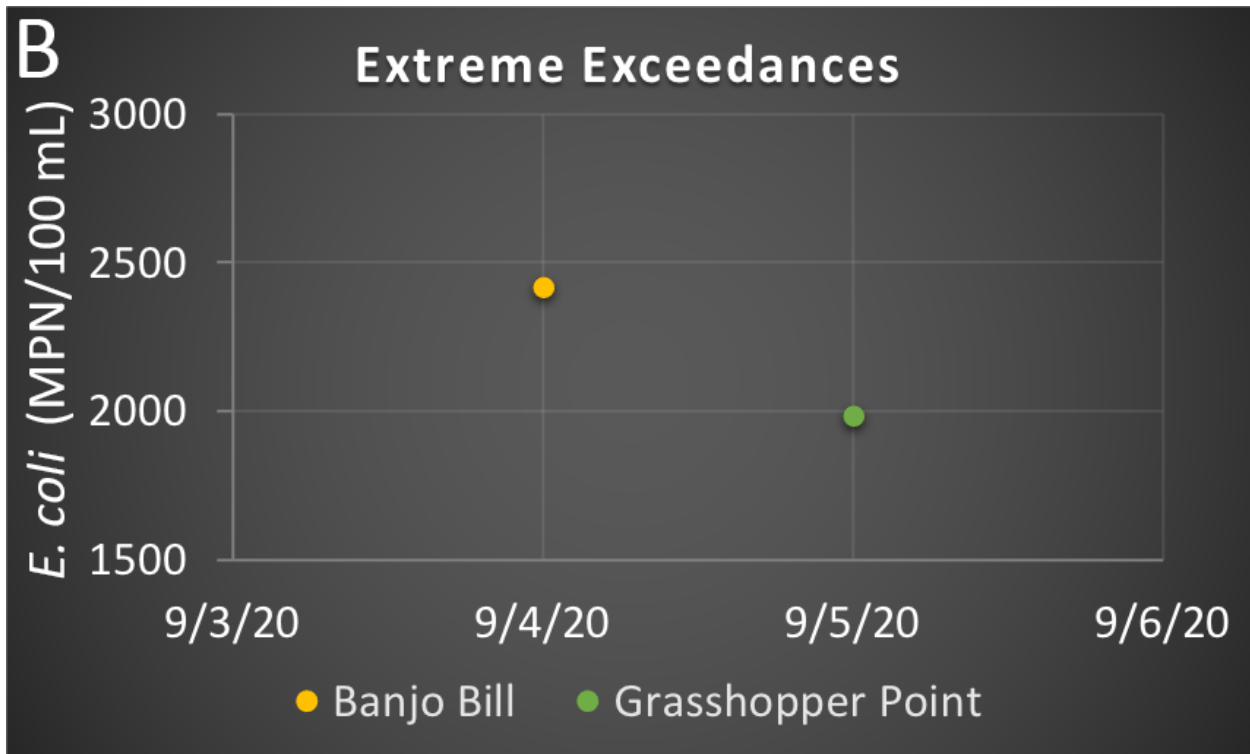
An exceedance occurred over most major holiday weekends of the summer but was not limited to holiday weekends as recreation was extremely high during most weekends. The single two highest exceedances occurred at Banjo Bill and Grasshopper Point, both over Labor Day Weekend and had values at 2419.9 and 1986.3 MPN/100 mL on 9/4/2020 and 9/5/2020, respectively.

Figure 5B. OCWC weekend sample extreme exceedances. Both exceedances captured over Labor Day Weekend 2020.

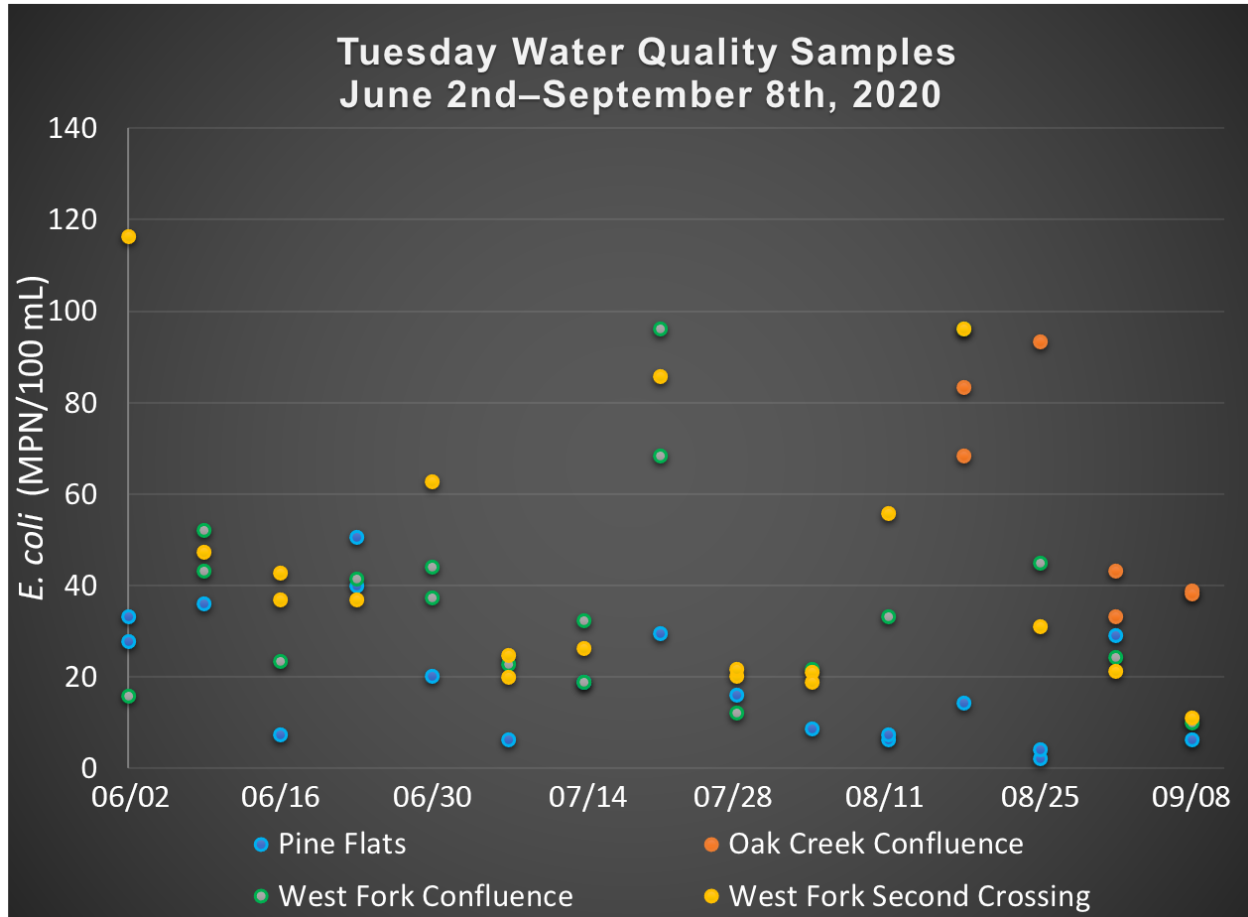
All 64 samples collected by OCWC are well below the state maximum of 235 MPN/100 mL (Figure 6). The highest *E. coli* value recorded came from West Fork at the Second Crossing (Figure 6). The sampler’s notes recorded that people crossed the creek while the sample was collected.

Figure 6. OCWC samples collected Tuesday mornings from June through September. Oak Creek Confluence site was added with only four sampling dates left.

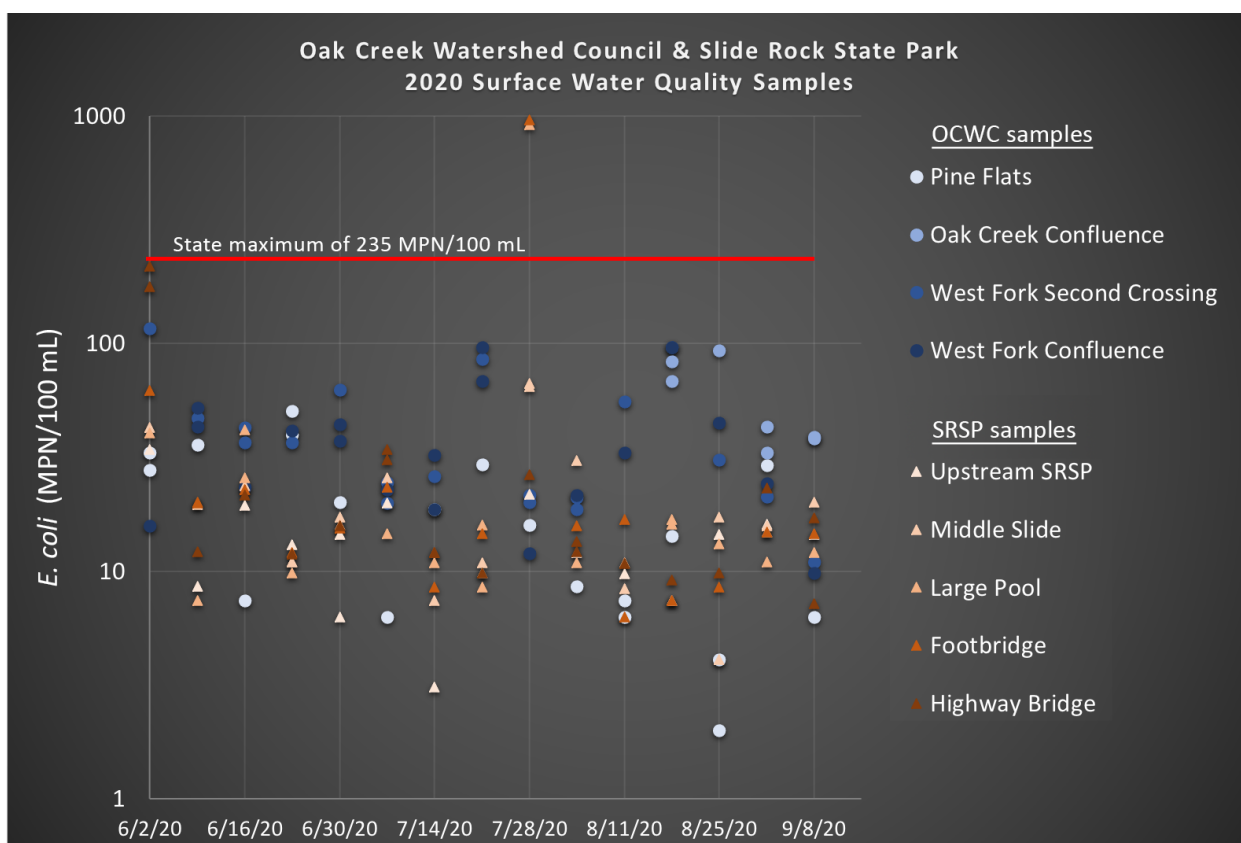
OCWC data alone (Figure 6) show zero exceedances. But when looked at alongside SRSP data, there were two exceedances (Figure 7). Both exceedances were captured by SRSP on the same day and at sampling sites adjacent to each other.

Figure 7. The graph shows all 148 water quality samples collected by OCWC and SRSP on a logarithmic scale.

Majority of the water quality samples collected were between 10 and 100 MPN/100 mL (Figure 7). There are a few samples that come close to being exceedances, captured on 6/2/2020, but are just below the 235 MPN/100 mL maximum. Two exceedances were captured at different locations that are just upstream and downstream of each site. It is possible the same source of *E. coli* bacteria was the cause for each exceedance. With OCWC and SRSP samples compared together as they are in Figure 7, it is apparent that for each day of sampling OCWC usually had higher concentrations of *E. coli* than SRSP collected.
