Oak Creek Project Report

Oak Creek Watershed Council

Comprehensive Project Report Encompassing All Work Throughout the 2019–2021 Term

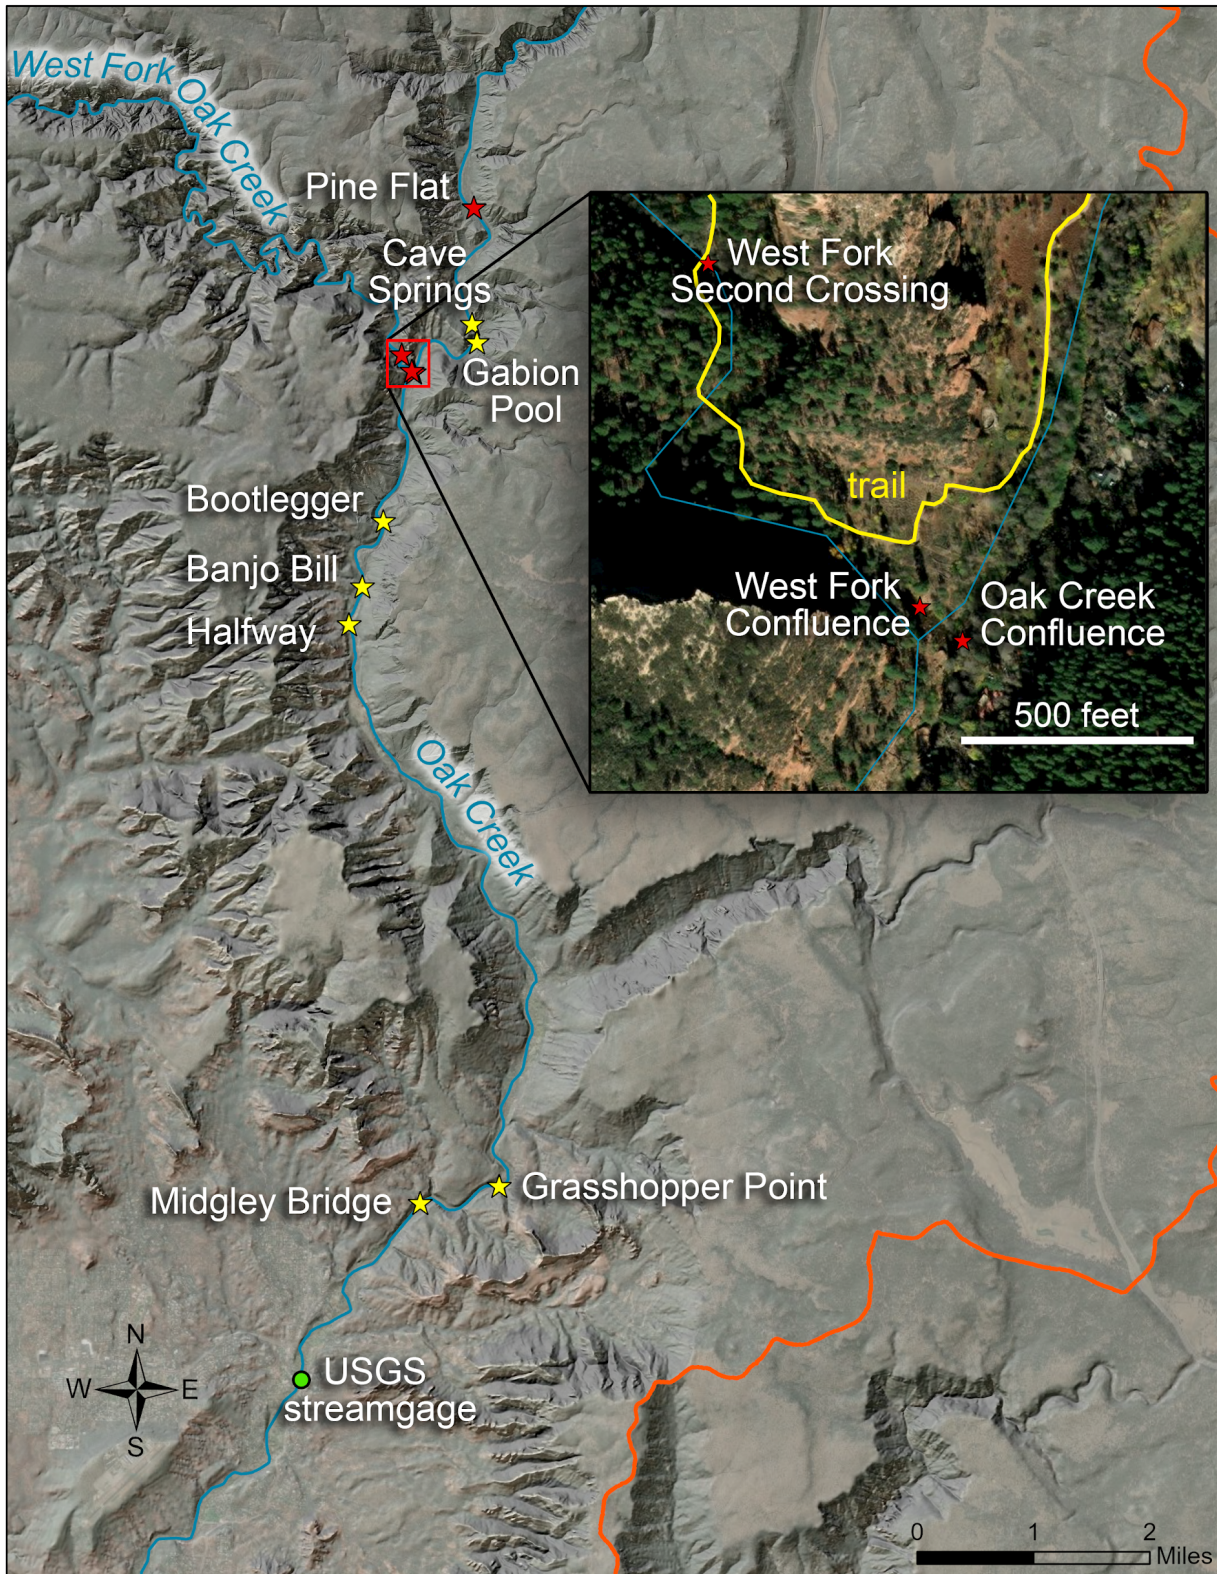
Figure 5. Map of OCWC surface water quality sampling sites. Red stars indicate the Tuesday baseline sampling sites and yellow stars indicate the weekend sampling sites.

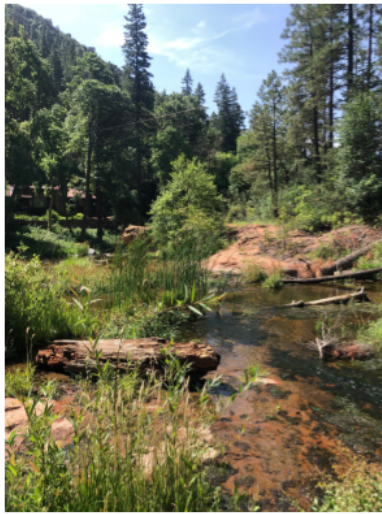
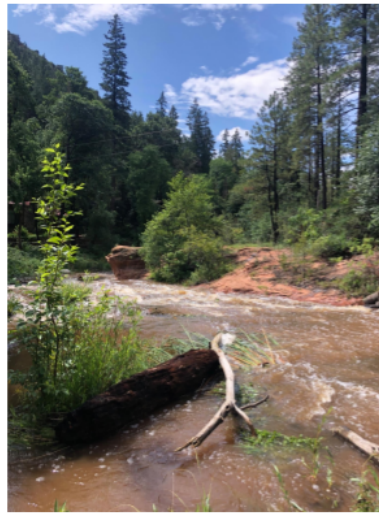
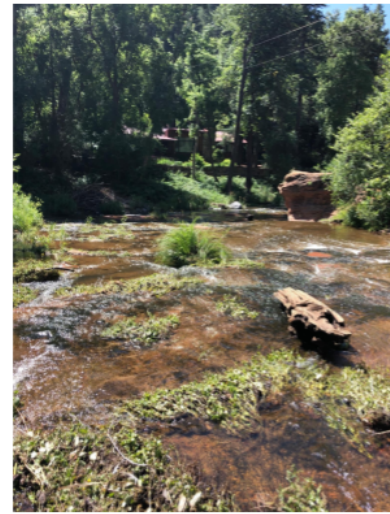
WFC sample site on Jul. 20, pre-flood.

Flood water seen at WFC on Jul. 24.
No samples were collected.

WFC sample site on Jul. 27 post-flood.
Notice vegetation cleared from flood.

Figure 6. West Fork at the confluence with Oak Creek sample site shown before, during and after flood event with flood waters seen on the 24th of July.

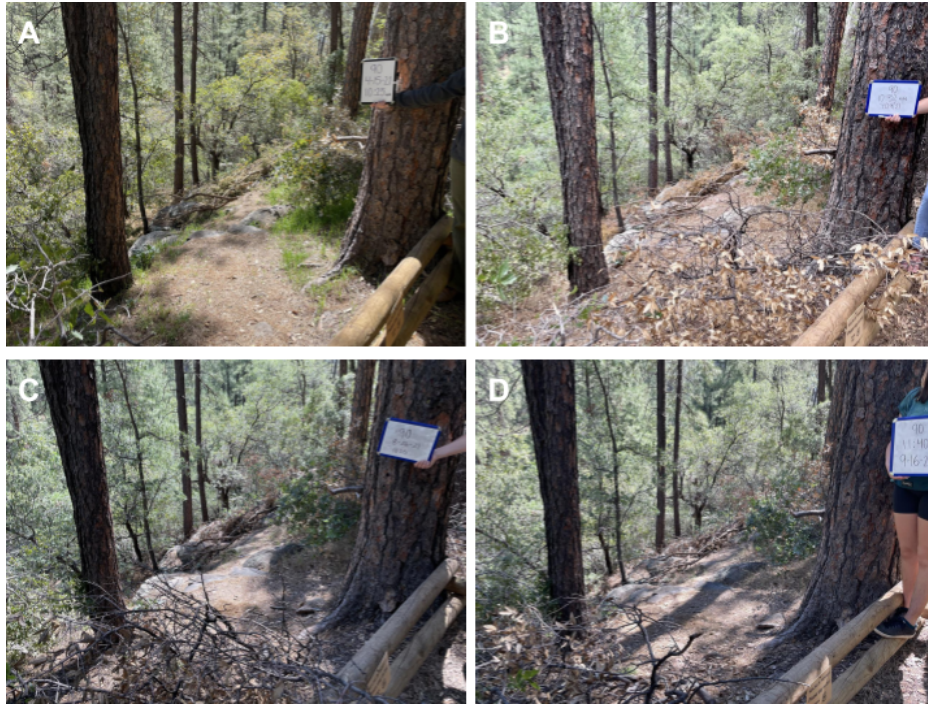
Figure 7. Social trail #90 near Manzanita Campground monitored four times from April–September 2021. In frame A, treatment was completed with the fence and signage but brush treatment was moved. Frames B and C show brush treatment was still in place but by September, frame D, brush was moved out of the way again.

The four trails monitored near Manzanita Campground from April–September 2021, were closed social trails with treatments including rock dam, brush chute, and fence and signage (Figure 7). All four trails monitored at this site saw noticeable use, either with trash left behind or seeing people use the trail even with the treatments.

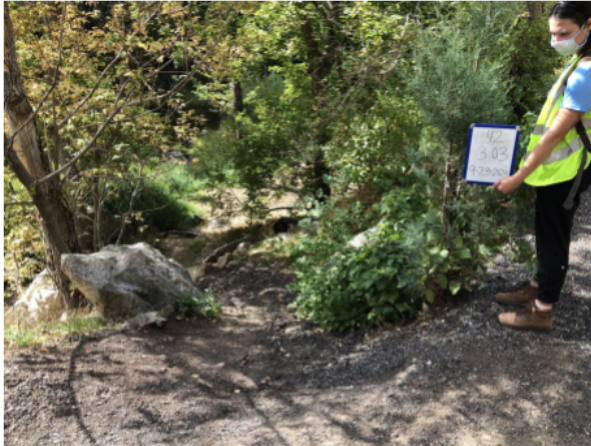
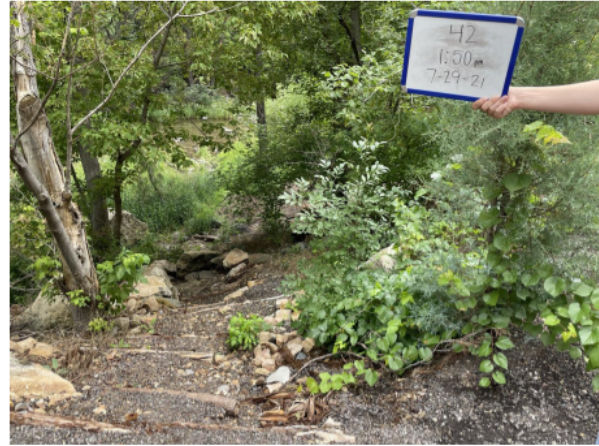
Social trail #42 made by recreators for creek access monitored before treatment on Sep. 23, 2020.

Social trail #42 shown rehabilitated with log steps for stabilization and continued access to creek on Jul. 29, 2021.

Figure 8. Social trail #42 near Cave Springs Campground left open for continued creek access.

The six sites monitored at Cave Springs from September 2020–September 2021 included three rehabilitated trails with log steps for stabilization, and three closed and naturalized trails with rocks and brush treatments. The three stabilized social trails were noted as frequently used trails to access the creek and were holding up well from the treatments (Figure 8). Two of the closed social trails remained effective and showed no signs of use whereas the third was not as effective and visitors were seen navigating around the log barrier treatment to access the social trail.

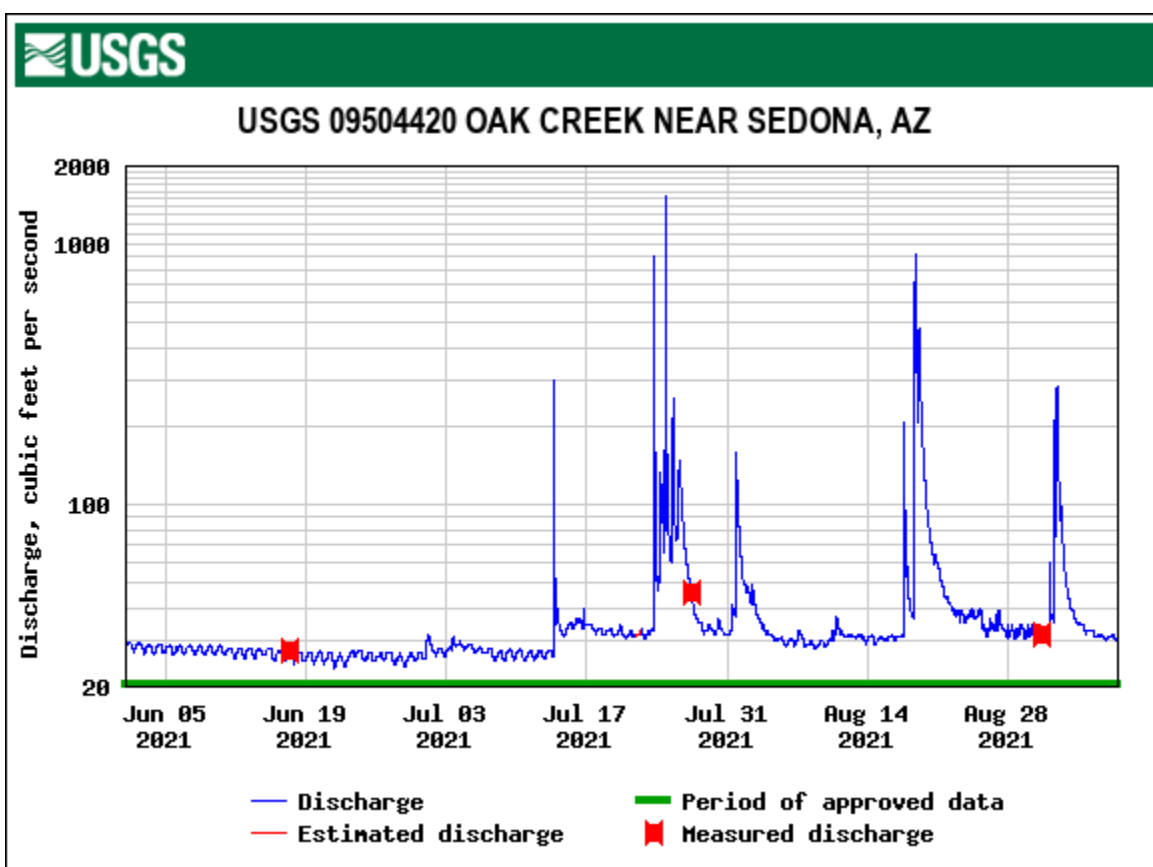
Figure 10. USGS streamgage data from Oak Creek near Sedona showing flow measurement in cubic feet per second (cfs) from June 1–September 7, 2021.

17th is another day of missed storm activity. In the morning during collection time, the creek was at 31 cfs but by 4:30 p.m., the creek reached 208 cfs and continued to increase to the second tallest peak in the figure at 911 cfs on August 18th at 6:07 p.m. When samples were collected on the 24th and 31st, the creek was back towards normal cfs. Thus, explaining a month of low E. coli numbers in terms of missed storm activity.

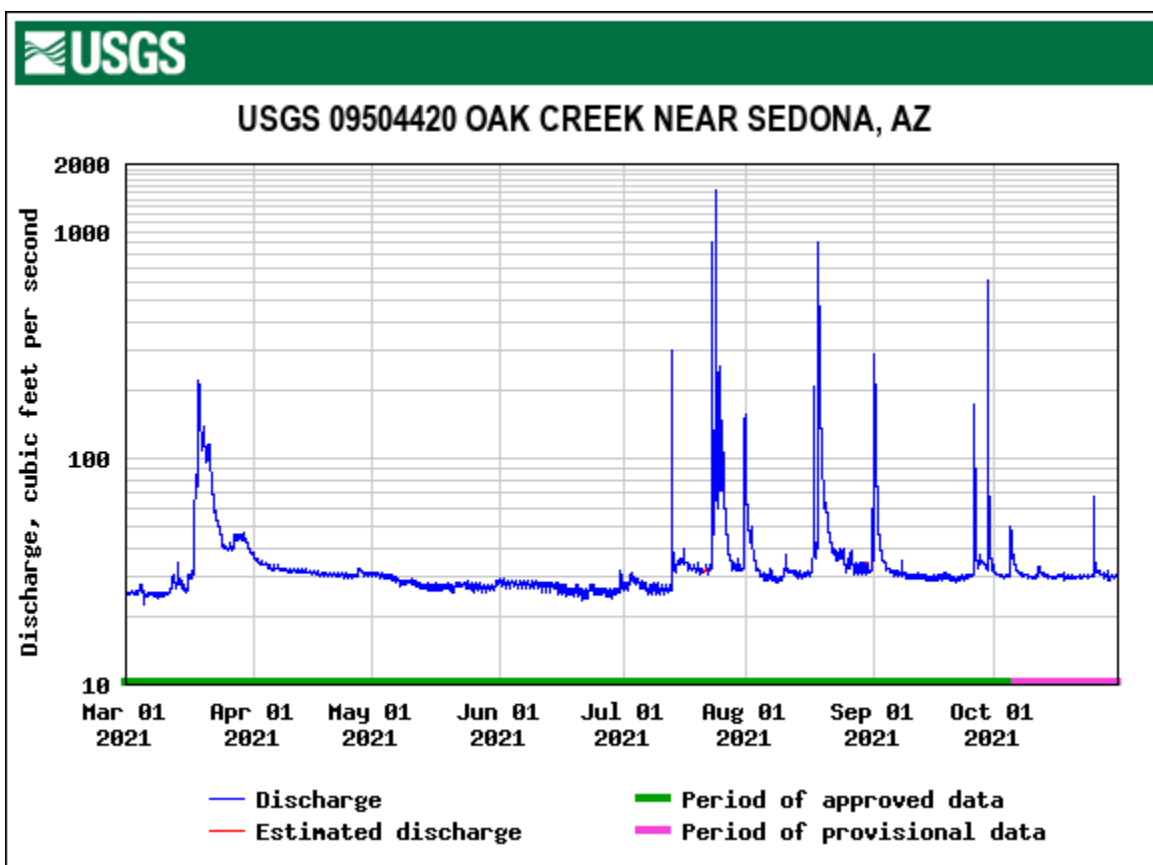
Figure 11. USGS streamgage data from Oak Creek near Sedona throughout the duration of HIR sampling project.

The USGS streamgage below (Figure 11), shows an early peak at 220 cfs on March 19th. OCWC's first HIR sampling day was the next day, March 20th, during NAU's spring break, however the rain and snowmelt didn't make for great spring break creekside activities. The creek was flowing at 110 cfs during sample collection on March 20th and while that is higher than normal, all samples showed low concentrations in *E. coli* bacteria ranging from 5.2 to 19.5 MPN/100 mL (See table A6 in Appendix). The low values in *E. coli* are likely because there was little human recreational activity in the water due to cold water temperatures in Oak Creek. Water temperatures ranged from 8.12 to 12.24 degrees Celsius (or 46.6 to 54 degrees Fahrenheit). Also, snowmelt is less rapid than rainwater. Higher water levels from snowmelt tends to be clear or slightly cloudy, while rainwater/stormwater is more **turbid** (See definition in Appendix), therefore bacteria is more likely to latch onto sediment particles suspended in the water column during stormwater events.

Figure 11 shows a peak at 911 cfs on August 18th and water levels stayed high through the 19th. When OCWC sampled again on the 21st, the water level was around 49 cfs. All samples from this day show *E. coli* concentrations at or near 200 MPN/100 mL, with one exceedance seen at Midgley Bridge showing 260.3 MPN/100 mL. This exceedance however is more likely due to recreation than residual stormwater because the sampler's notes say, "Sample site had 2 dogs and about 40 people. Many young kids (around 10 years old) were riding the water "slide" down and down again as the sample was being collected. Some college age adults on the beach and in the water also."

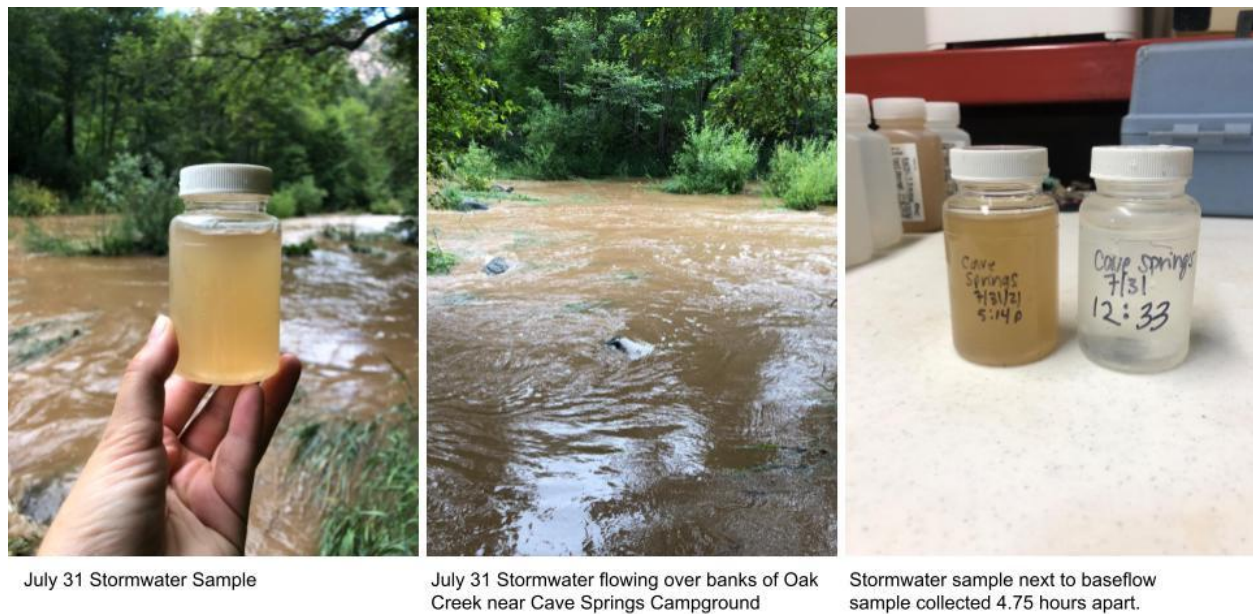
Figure 12. Stormwater flow on Oak Creek July 31, 2021.

Midgley Bridge, then headed back to the Natural Channel Designs Laboratory in Flagstaff. While driving north, we saw stormwater raging at the Cave Springs sampling site and stopped to collect our first (and only) stormwater sample of the season. Figure 12 below shows the stormwater sample, stormwater, and stormwater sample next to a baseflow sample, both of which were exceedances, including the duplicate. The stormwater sample was processed four times in different concentrations. First, it was left as 100 mL and processed, then diluted to 10 mL and 90 mL DI water, then 1 mL of the stormwater and 99 mL of DI water and finally, 0.1 mL of the stormwater with 99.9 mL of DI water. Both the 100 mL sample and 10 mL sample were exceedances. The other exceedance of the day was from Grasshopper Point which can be attributed to high recreation because of the additional upstream of Grasshopper Point sample that was collected this day and did not show an exceedance (See table A6 in Appendix).

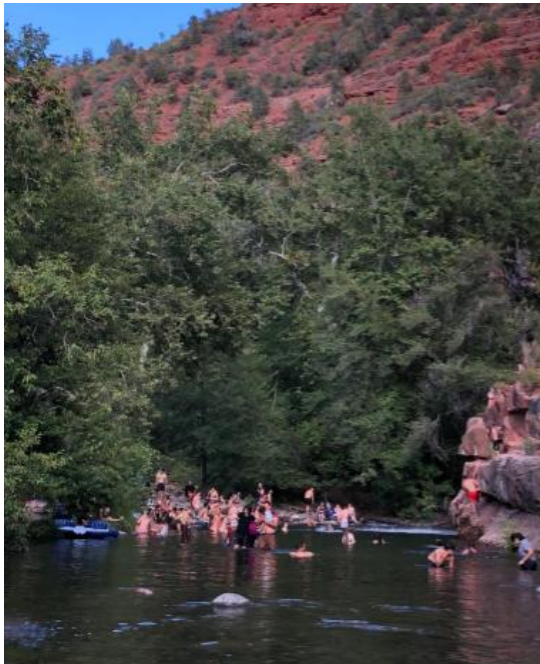
Labor Day Weekend 2020 at Grasshopper Point, Over 200 people counted at the day use site.

Figure 13. Crowding in Oak Creek Canyon in 2020 was more frequent than in 2021.

Although recreation is normal, good, and fun, high recreation can impact water quality as seen by sampling over the past two summers. 2020 showed exceptionally high recreation as can be seen in the figure below (Figure 13). Labor Day Weekend 2020 side by side to 2021 shows the density of people recreating in small swimming holes.

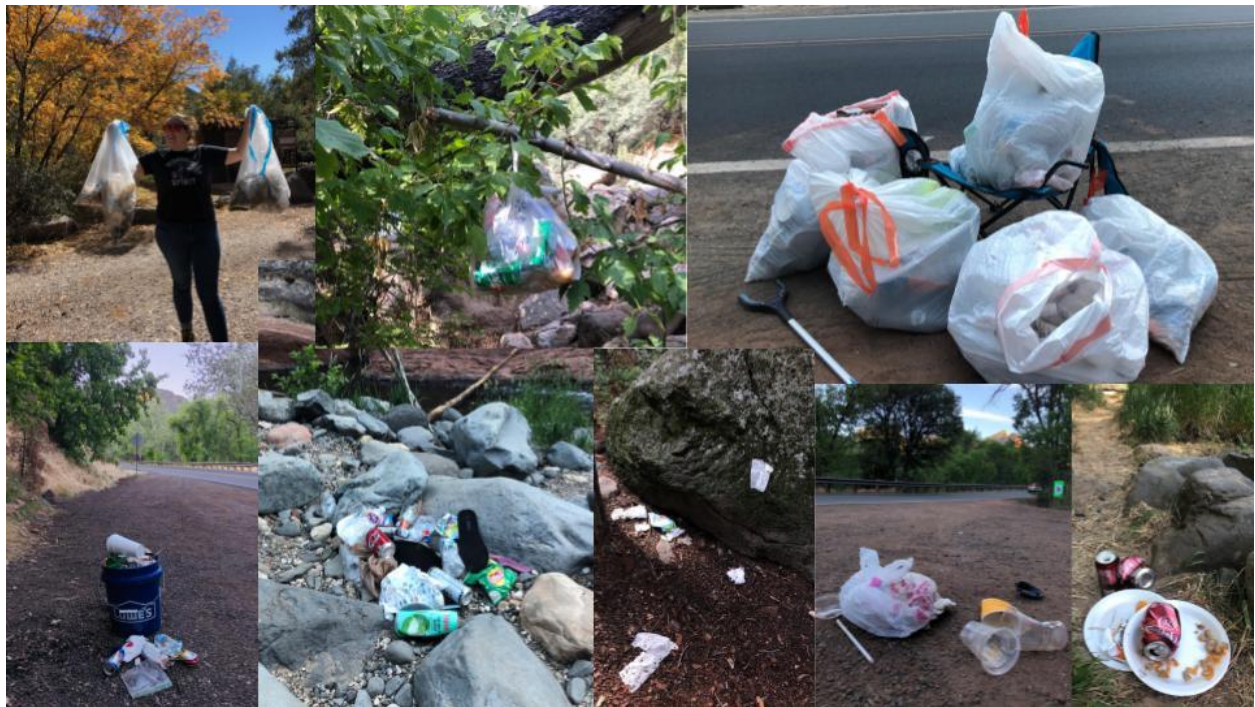
Figure 14. Just some of the trash Ambassadors removed while doing canyon patrol in 2020 and 2021.

Canyon patrol by Ambassadors saw another successful year in 2021, removing 1,124.25 lbs of trash from Oak Creek Canyon. There was less trash collected in comparison to 2020, where 1,825.74 lbs of trash was removed (table 2 and figure A1 in Appendix). It is important to note that Table 2 consolidates 37 sites visited by Ambassadors for canyon patrol into 13 generalized areas that are known sites within Oak Creek Canyon. The reduced amount of trash is likely attributed to the reopening of indoor spaces in 2021. Ambassadors also noticed a reduced amount of visitors and vehicles in the canyon. High use weekends like holidays were still very busy, and some areas with limited capacity or small parking lots like Grasshopper Point and Midgley Bridge during the summer, and West Fork, Gabion Pool, and Cave Springs pullouts during the fall, proved to be hard areas to access for Ambassadors during the high use season. It is very likely that there was more trash present than recorded due to the accessibility issues Ambassadors faced. Yet with only two to three people at a time picking up litter on the

weekends throughout Oak Creek Canyon, canyon patrol proves to be a very successful program in removing trash from pullouts and day use sites (Figure 14).

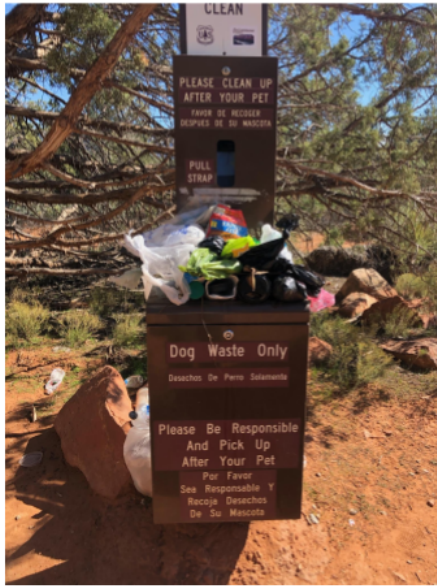
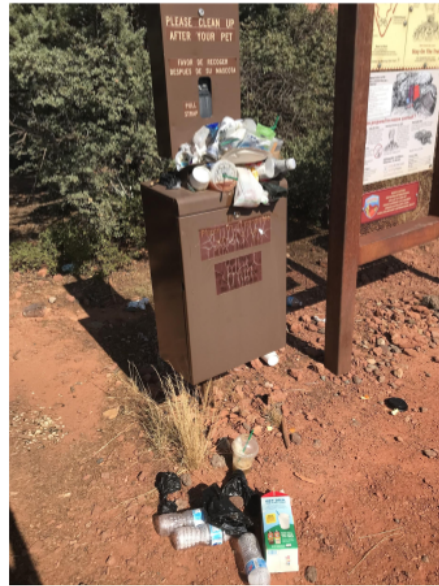
Soldiers Pass misuse/overflow 2020

Mescal misuse/overflow 2019

Figure 15. Photos depicting misuse and overflow of Soldiers Pass and Mescal pet waste stations.

With the addition of four new stations, it was expected that some or all of the new stations would have some misuse, but a substantial amount of misuse has been noted by Ambassadors at the Bell Rock and Cathedral Rock trailheads (Figure 16), both extremely popular trails within the Red Rock Ranger District. Including Bell Rock and Cathedral Rock, five out of the ten pet waste stations have accessible trash bins managed by the Forest Service, typically found near existing structures like a bathroom or informational boards. Including this, there is strong messaging (Figure 17) on the pet waste stations informing recreationists that these bins are for pet waste only. Although these stations are often misused by recreationists, overall these stations have prevented a substantial amount of pet waste and trash alike from entering local waterways, and proves to be a successful collaborative project.

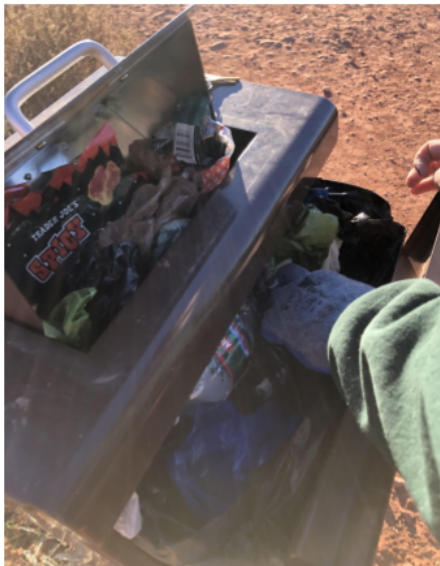
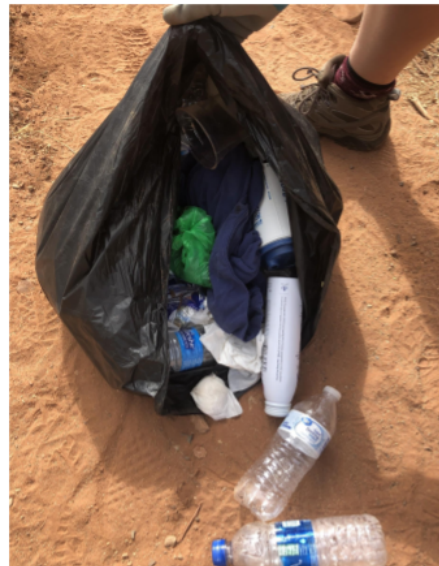
Bell Rock misuse/overflow 2021

Cathedral Rock misuse/overflow 2021

Figure 16. Photos depicting misuse and overflow of Bell Rock and Cathedral Rock pet waste stations.

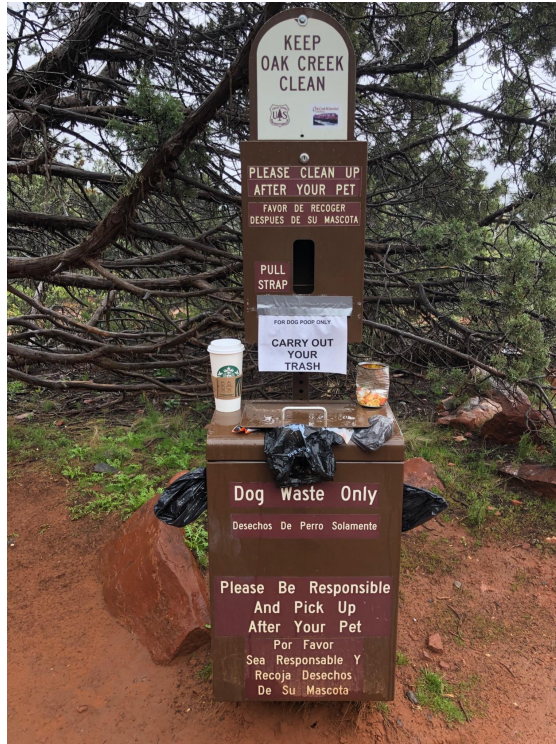
Figure 17. Photo depicting pet waste station messaging and additional messaging reminding recreationists to pack out their trash.

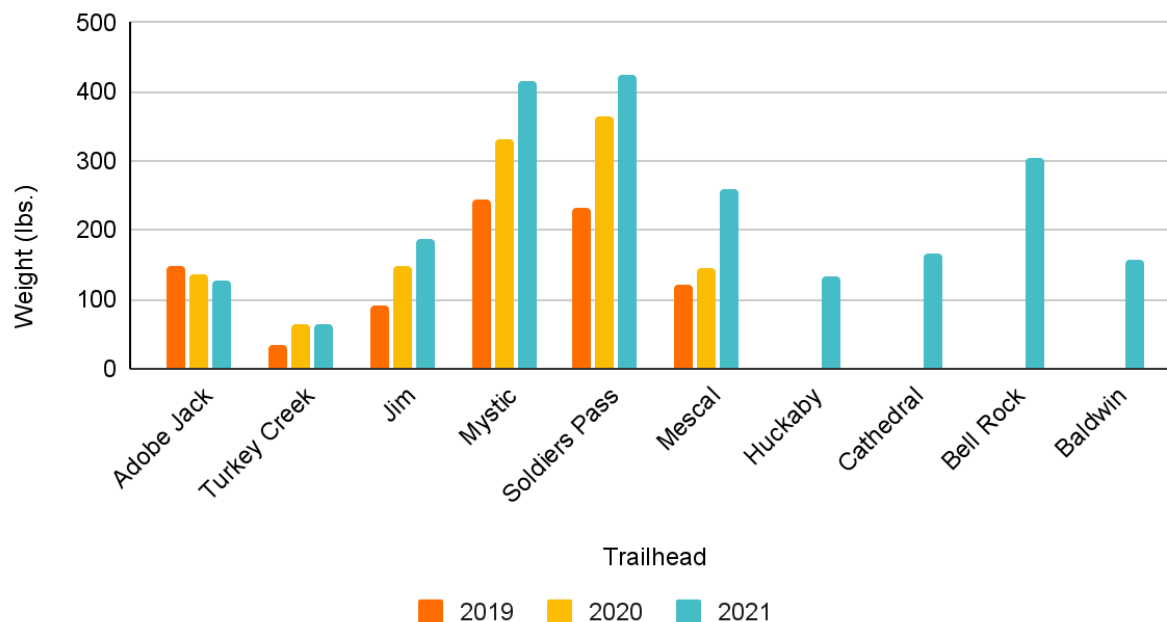
Figure A2. Bar graph depicting total weights for pet waste stations at different USFS trailheads. Note that Huckaby, Cathedral, Bell Rock, and Baldwin only have values occurring in 2021, as these stations were not installed until May 2021.

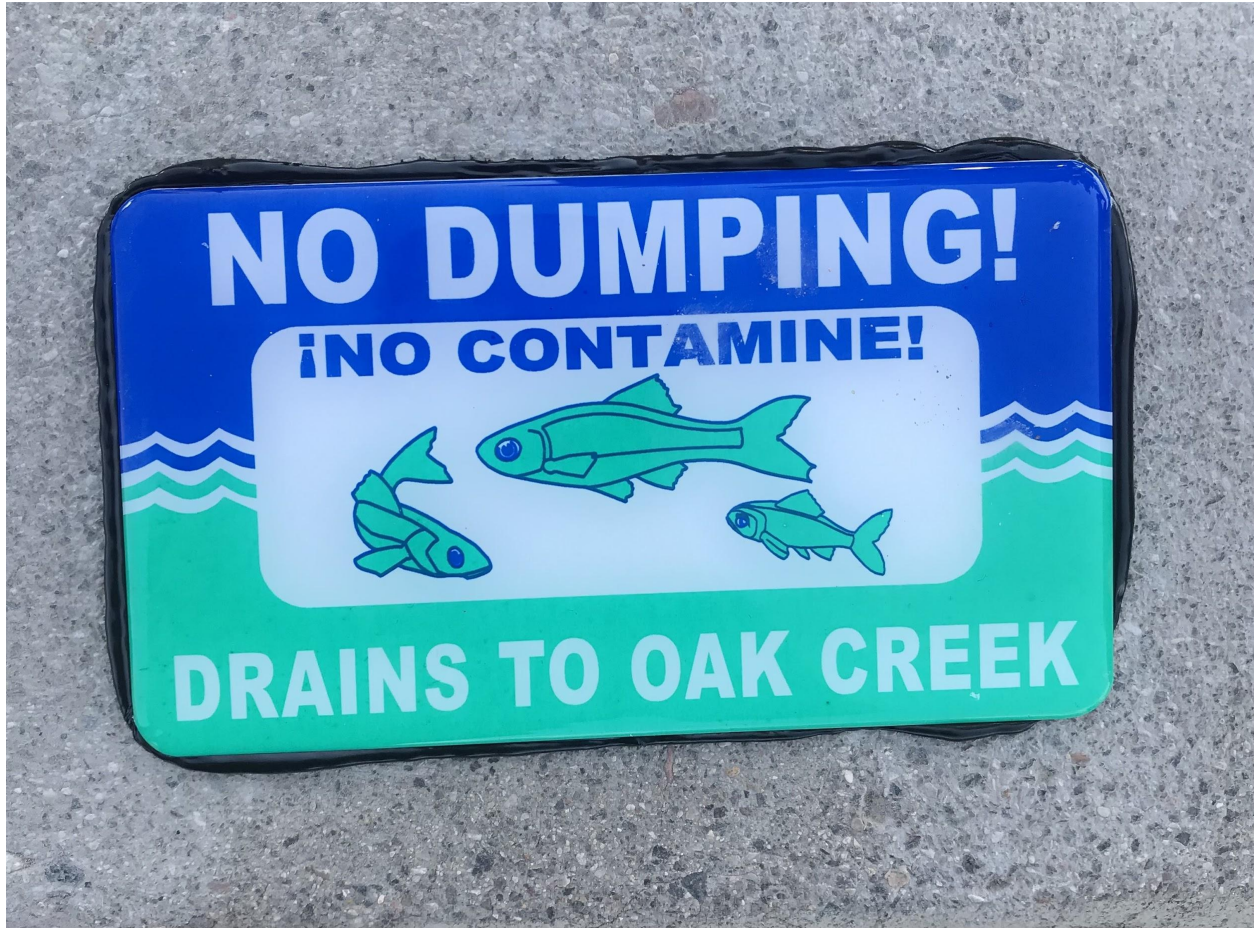
Figure A4. "No Dumping! Drains to Oak Creek" curbside placard installed near a storm grate in the City of Sedona.

Outreach and education of Sedona's MS4 was conducted through canvassing homes and businesses, performing curb marker installations (See figure A4 in Appendix), tabling at the Sedona Community Farmers Market with the visual relief model (See figure A5 in Appendix), and by the creation of social media posts and newsletters.

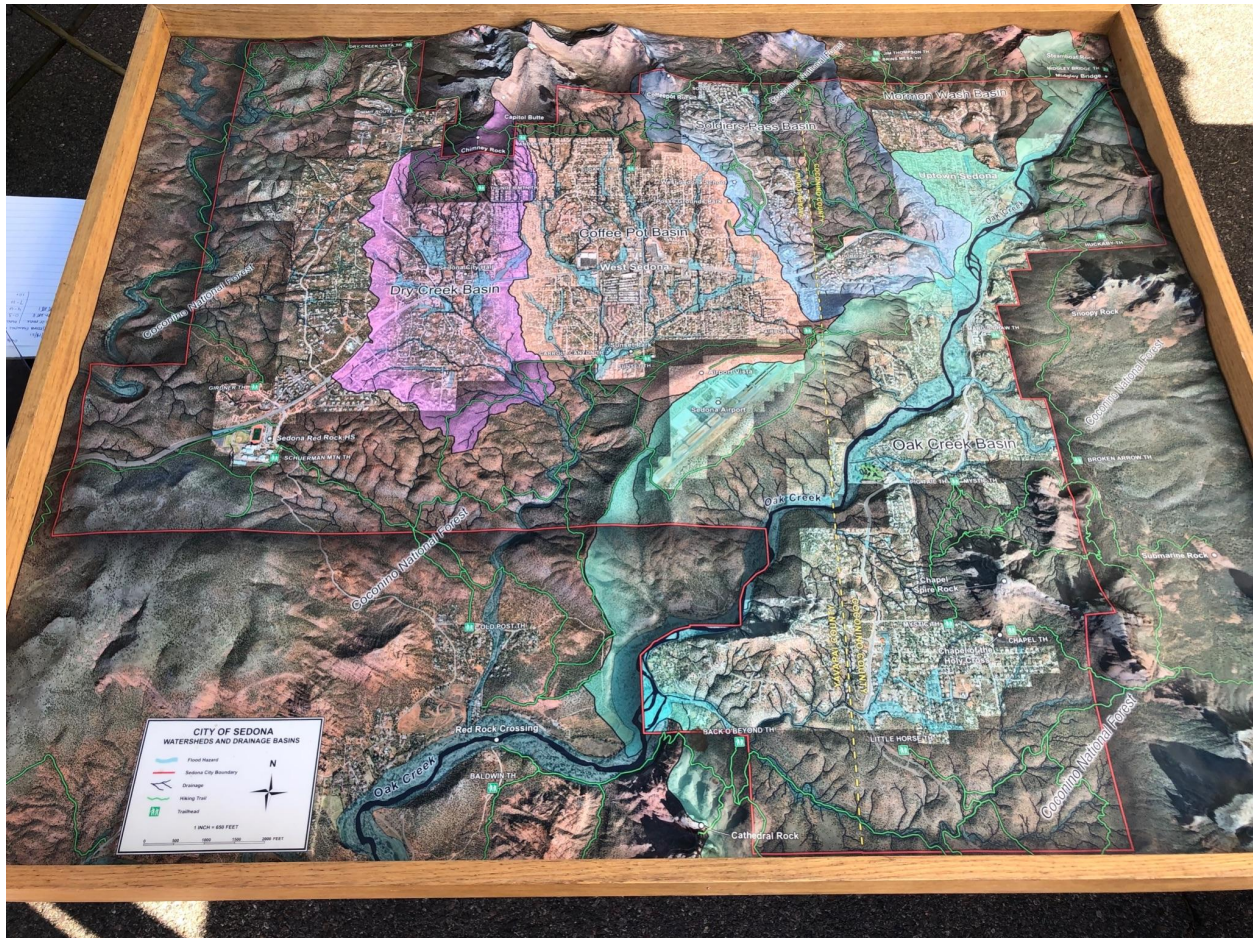
Figure A5. Shaded relief model of basins and drainages within the City of Sedona showing where the MS4 flows into Oak Creek.
